TBF/TBM Avenger

Walk Around Number 25
squadron/signal publications

By Lou Drendel

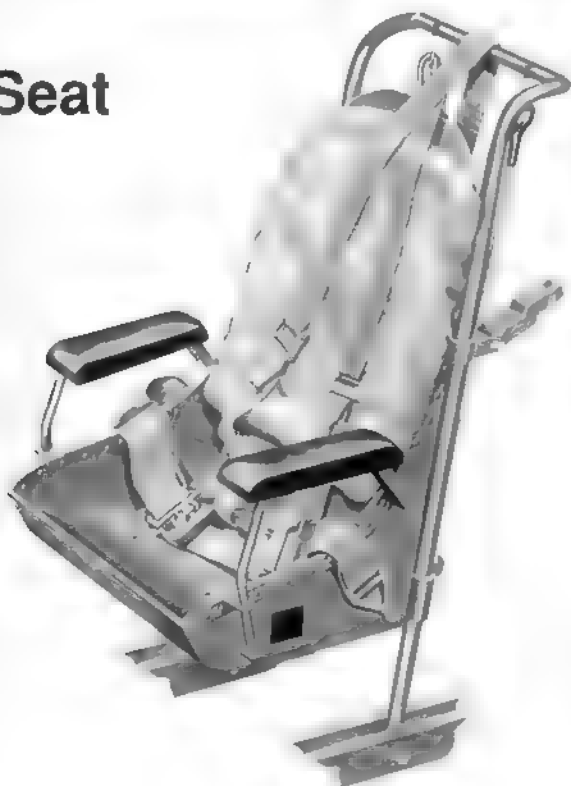
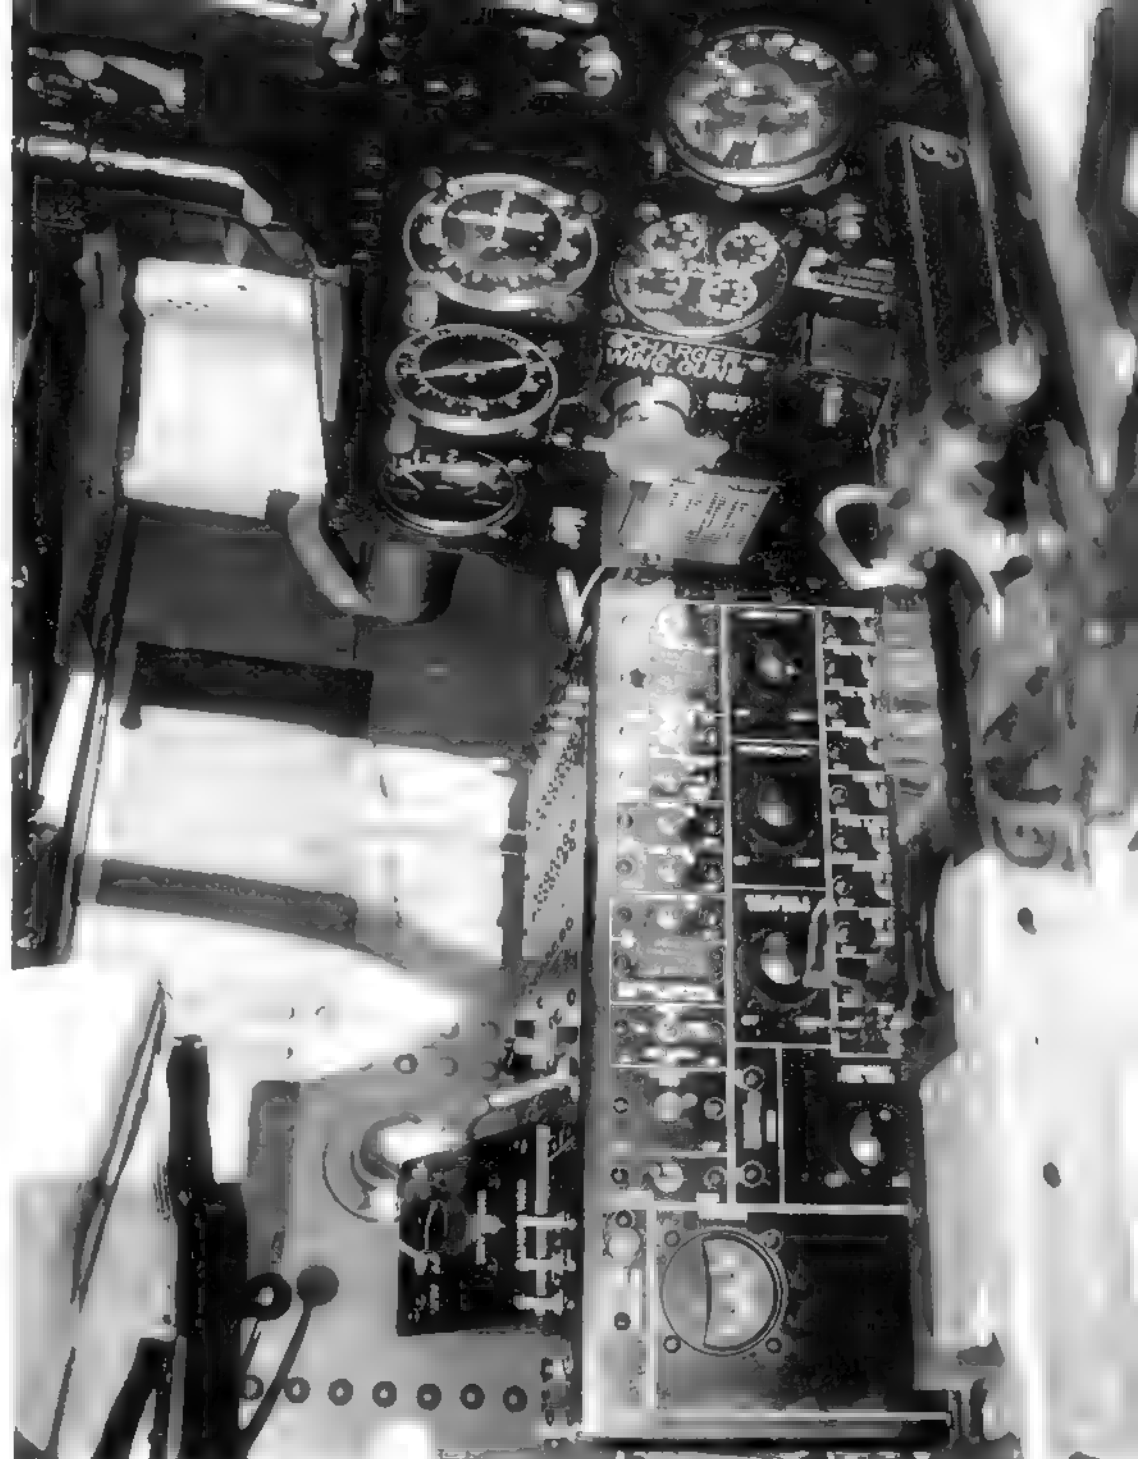
Pilot's Seat

The Electrical Distribution Panel on the front cockpit's starboard console contained light switches, the radio master control switch, heater controls, armament switches, and circuit breakers. The Cavanaugh Avenger's panel is historically accurate. Various switches on the Instrument Black console are silver and red. The starboard rudder pedal was mounted just above the cockpit floor; the port pedal was fitted in the same way. (Lou Drendel)

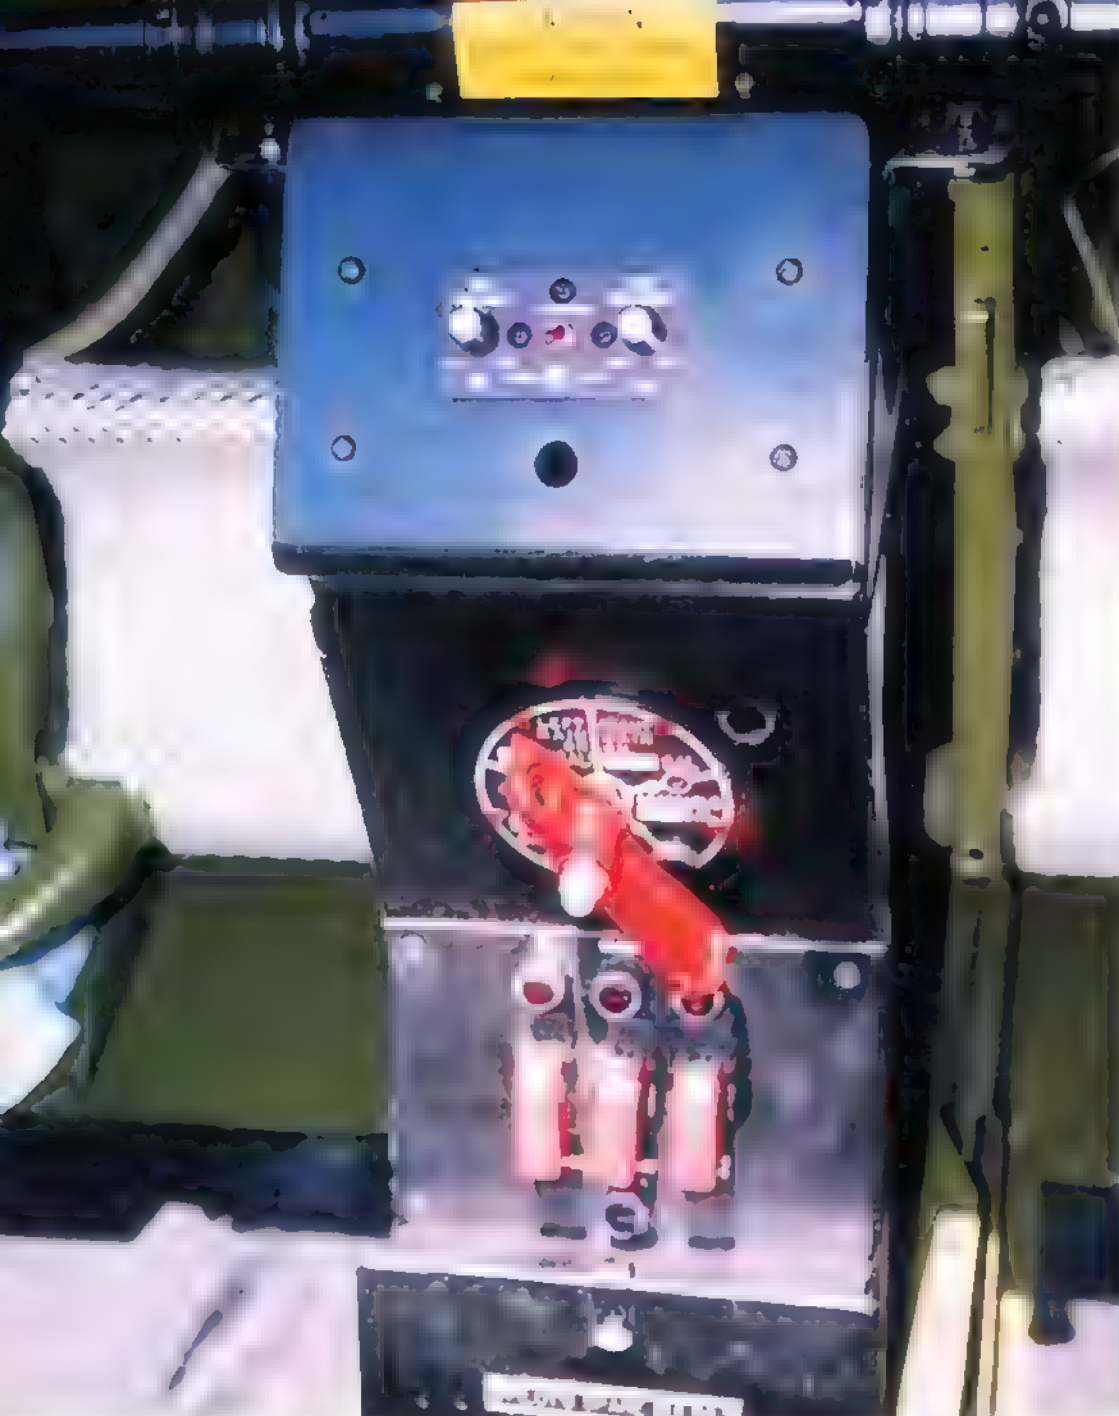
The pilot's center cockpit panel on Cavanaugh's TBM-3 was retrofitted with a modern intercom panel replacing the remote indicating compass. The intercom system enabled the pilot to communicate with the other crewmen elsewhere on the aircraft. The red fuel tank selector switch enabled the pilot to select one of the Avenger's fuel tanks to draw fuel from to keep the aircraft in proper trim. Red switch covers were placed over the three fuel pump switches. (Lou Drendel)

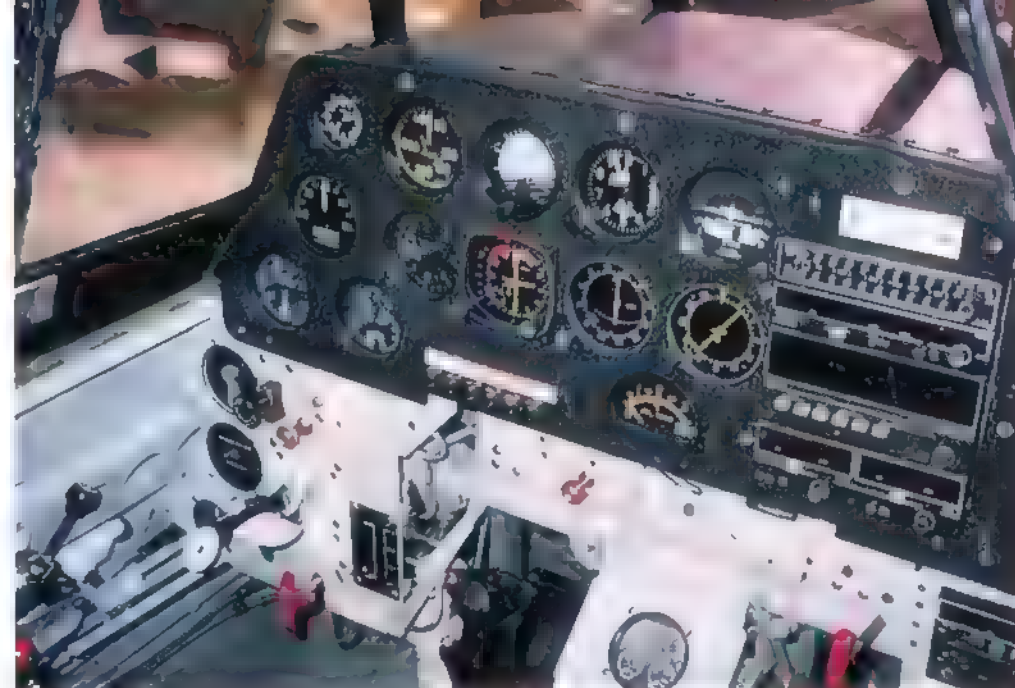
The TBM (N700RW) owned by the Lone Star Flight Museum in Galveston, Texas was fitted with modern avionics and instruments. This arrangement does not resemble the original aircraft's instrument panel in any way. The control stick grip is a modern type with multiple task buttons, not the relatively simple grip used on wartime Avengers. The upper portion of the instrument panel is Flat Black, while the rest of the cockpit interior is a light blue-gray (approximately FS35526). (Lou Drendel)

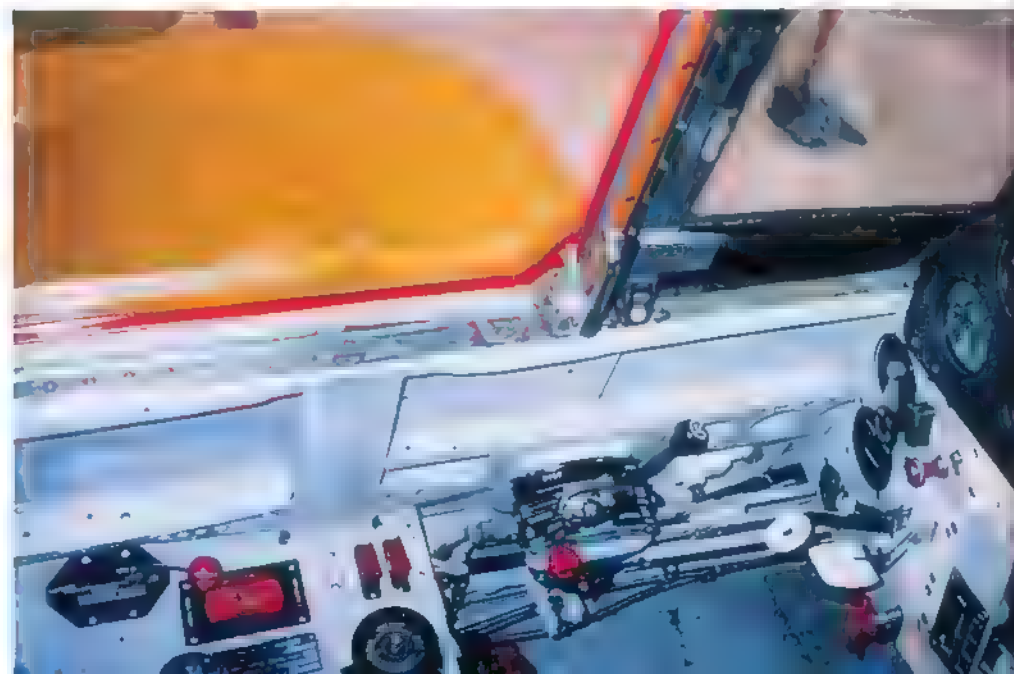
The port cockpit controls on the Lone Star Flight Museum's Avenger are in their original positions; however, the light blue-gray finish applied to this aircraft is incorrect. The round black knob on the fore end of the console was the rudder trim tab control. Below and slightly ahead of this knob – along the front of the console – was the aileron trim tab control wheel, which adjusted the TBM's aileron trim tabs as required under various flight conditions. (Lou Drendel)

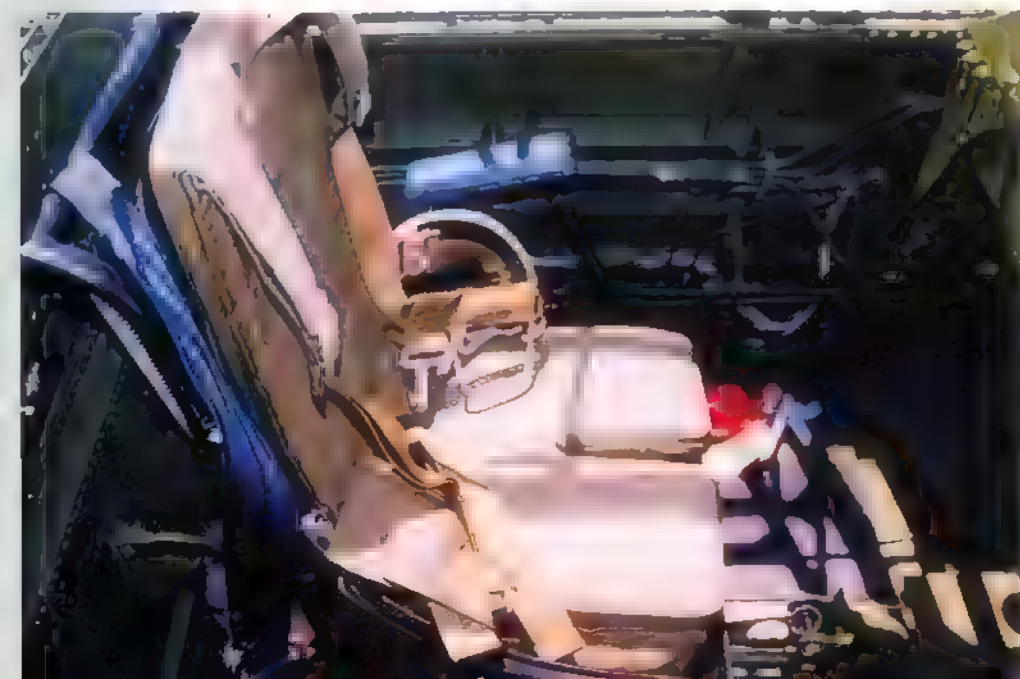
The radio operator's chair – not standard on Avengers after the TBF-1 – was fitted to the Cavanaugh Flight Museum's TBM-3. This center cockpit restoration is close to the original, the only exception being the red modern fire extinguisher fitted along the port cockpit wall just ahead of the pilot's seat. Most Avengers from the TBF-1C replaced the chair with radio equipment; however, the British used this seat on their Tarpon (later Avenger) Mk IIs (TBF-1Cs). (Lou Drendel)

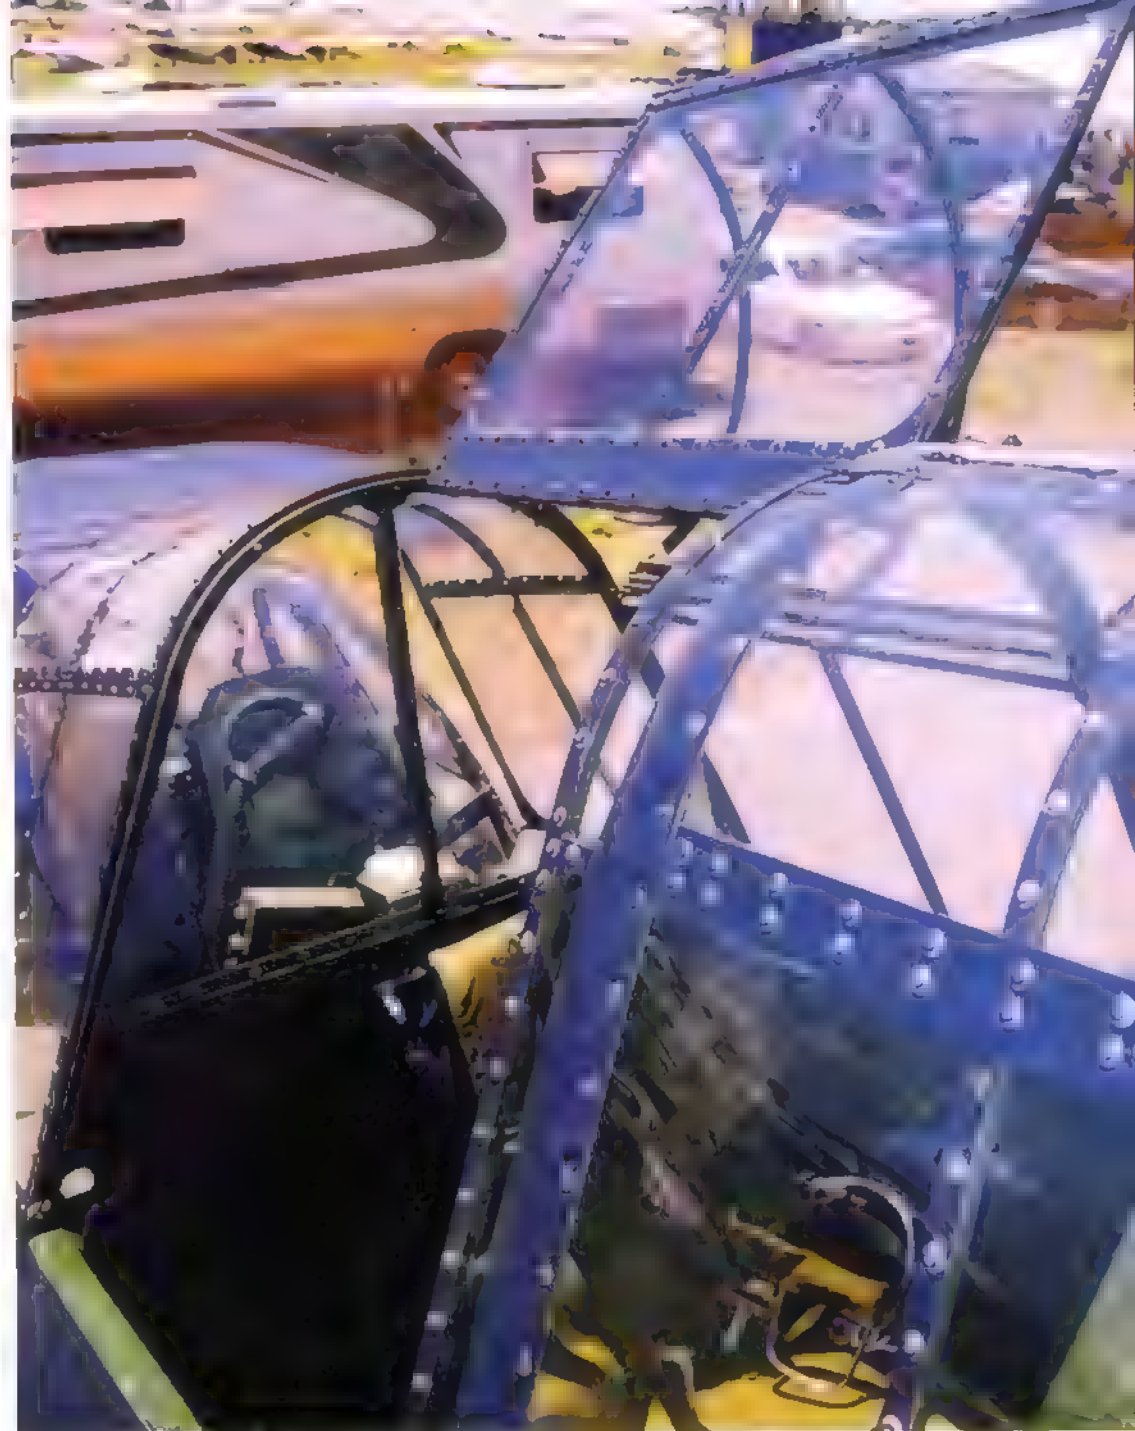
The radio operators canopy was located just forward of the Avenger's turret. The starboard and center sections hinged to port, while the left panel remained fixed in position. There were no clear panels separating the radio operator's cockpit from the aft canopy and rear turret. The canopy inner surfaces were painted Interior Green (FS34151), while the exterior surfaces were finished Glossy Sea Blue (FS15042) to match the fuselage exterior. (Lou Drendel)

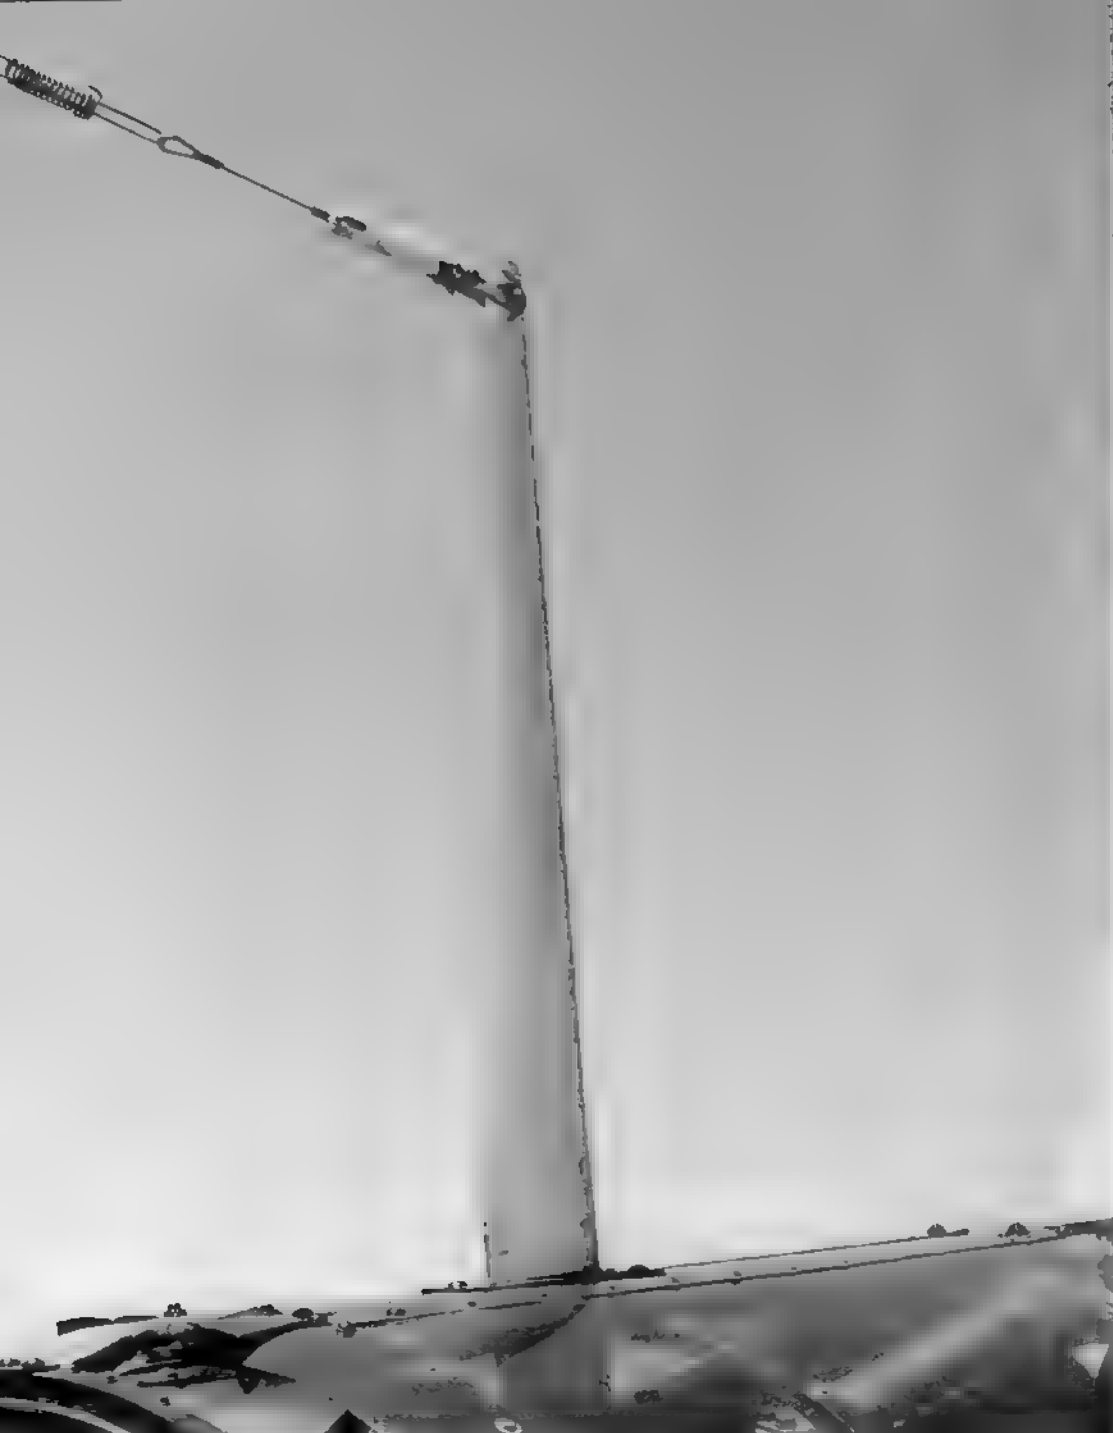
The TBM-3's radio antenna mast was mounted atop the canopy, immediately ahead of the radio operator's cockpit section. The wire antenna led from the top of this mast to a short mast atop the rudder. A secondary wire antenna was usually mounted from the main wire antenna to the mid-fuselage just ahead of the turret. The Avenger was equipped with an AN/ARC-1 VHF (Very High Frequency) radio, which had nine main channels (frequencies) and one guard (emergency) channel. (Lou Drendel)

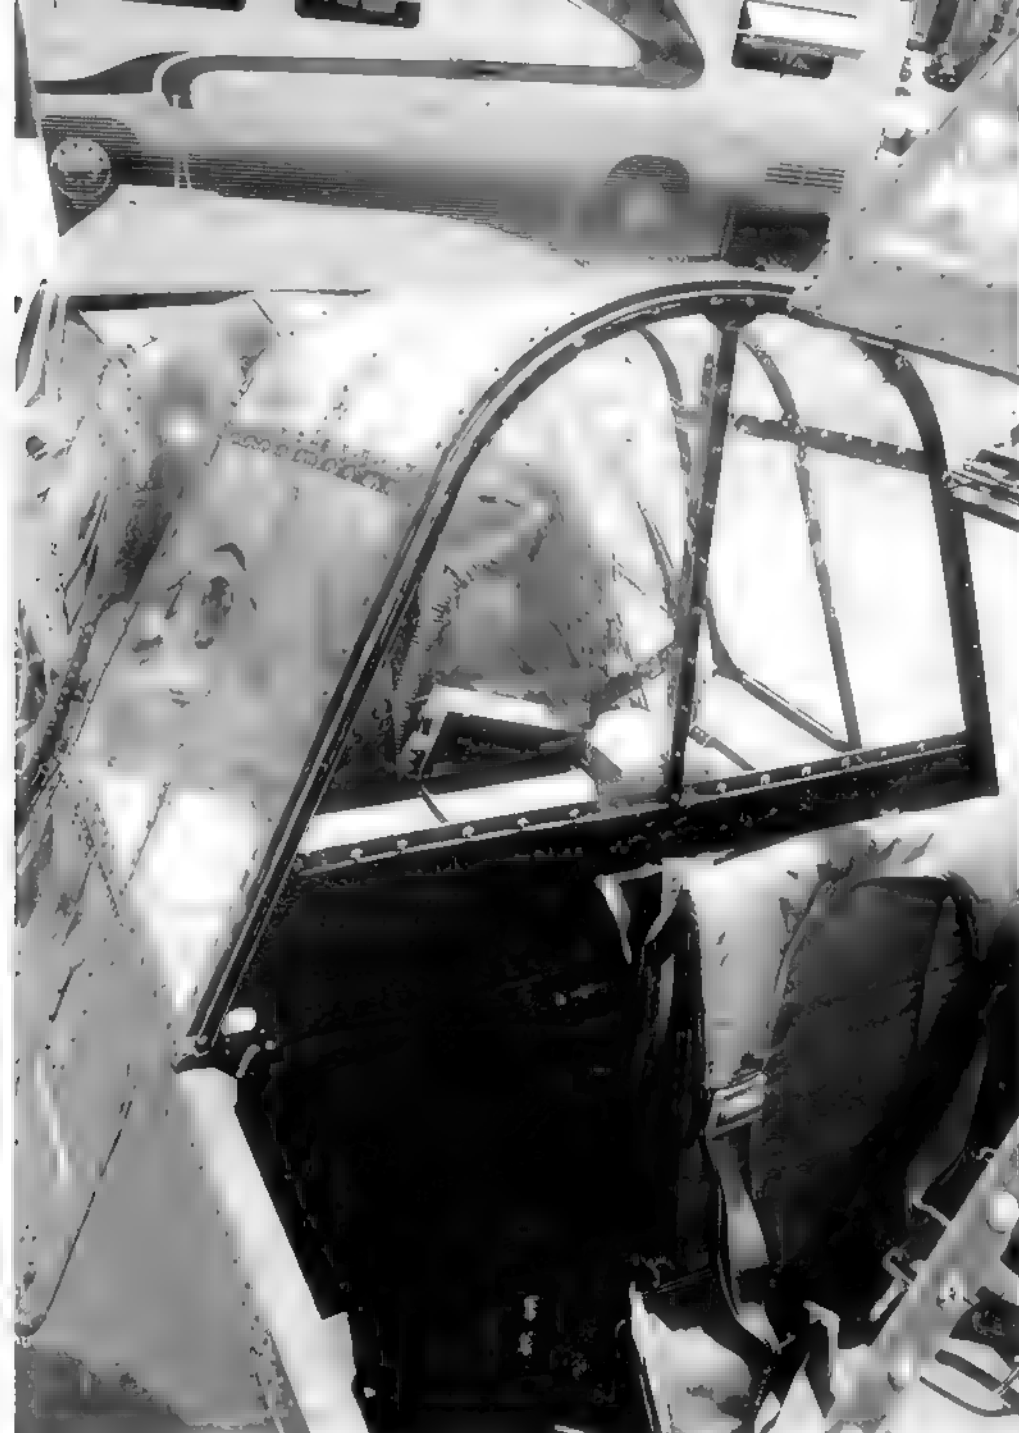
The access door to the navigator/bombardier compartment was immediately starboard of the radio operator's seat. The radio operator passed through the doorway, crawled past the turret, and went down into the bombardier's position during level bombing missions. This door was kept shut when the radio operator's station was relocated to the aft fuselage under the gun turret. (Lou Drendel)

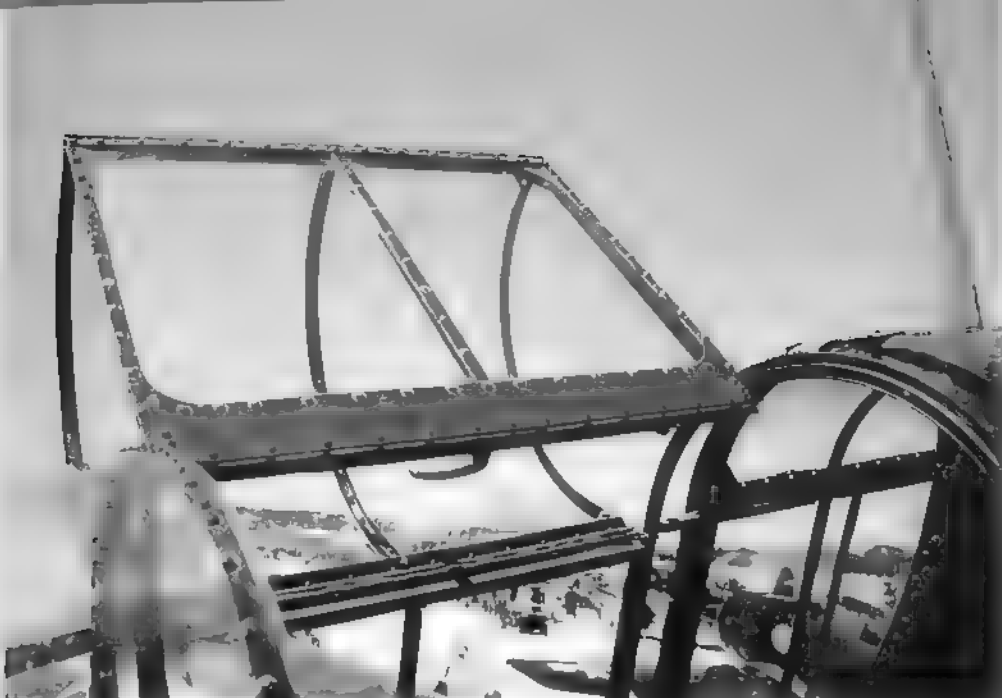
The radio operator's canopy was hinged to port, with the starboard and center sections folding to allow access to and egress from the TBF/TBM's center cockpit. Entry to this station was only over the wing from the Avenger's starboard side. Piano hinges were used to join the three sections of this canopy. (Lou Drendel)

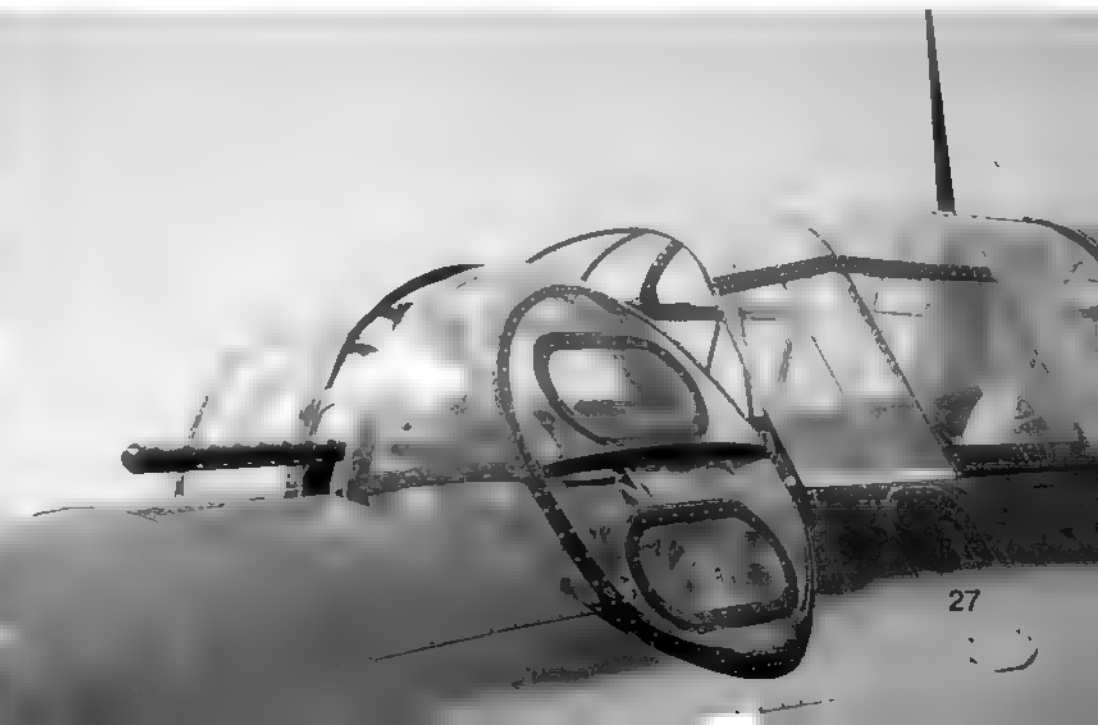
The Avenger turret mounted one .50 caliber (12.7mm) Colt-Browning M2 machine gun, which was offset to the gunner's left. This weapon was supplied with 200 rounds of ammunition and could be reloaded with 200 more rounds at any time during flight. The machine gun's elevation ranged from -30° to +85°. The gun camera mounted in the turret's upper surface recorded firing results for later study. (Lou Drendel)

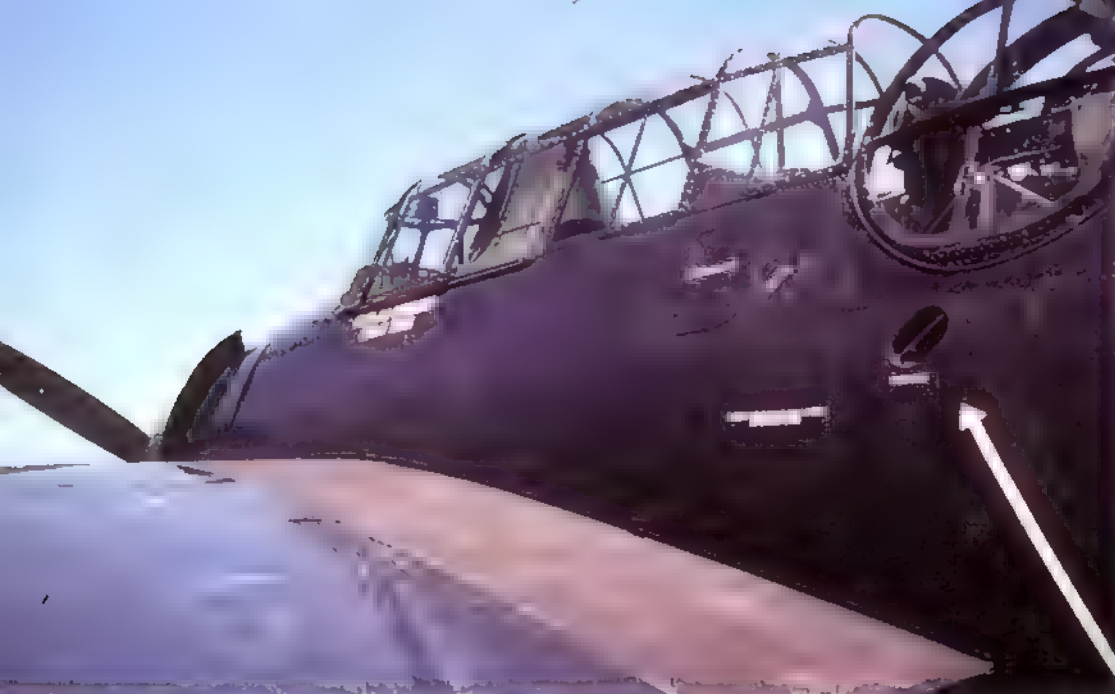
The TBF/TBM's gun turret protected the aft and side uppersurface of the aircraft from enemy fighters. A flush-mounted handhold under the turret assisted crewmen in climbing aboard the port side of the Avenger. The wingwalk areas were covered with a non-skid surface to ease the footpath for flight and maintenance personnel. (Lou Drendel)

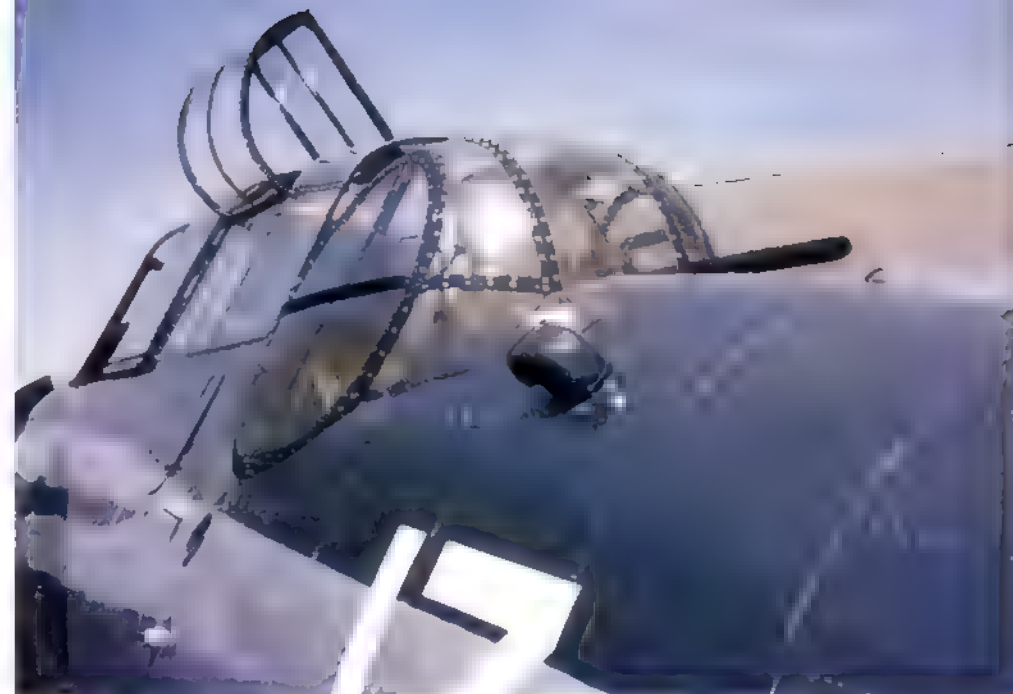
The .50 caliber Browning M2 machine gun was offset to the gunner's left to allow space for the gunner and his sighting equipment. The gunner used a ring and post gunsight – mounted behind 1.5 inch (38.1mm) thick bulletproof glass – to aim his weapon. The machine gun was trained and fired using a pistol-grip control device mounted under the gunsight. (Lou Drendel)

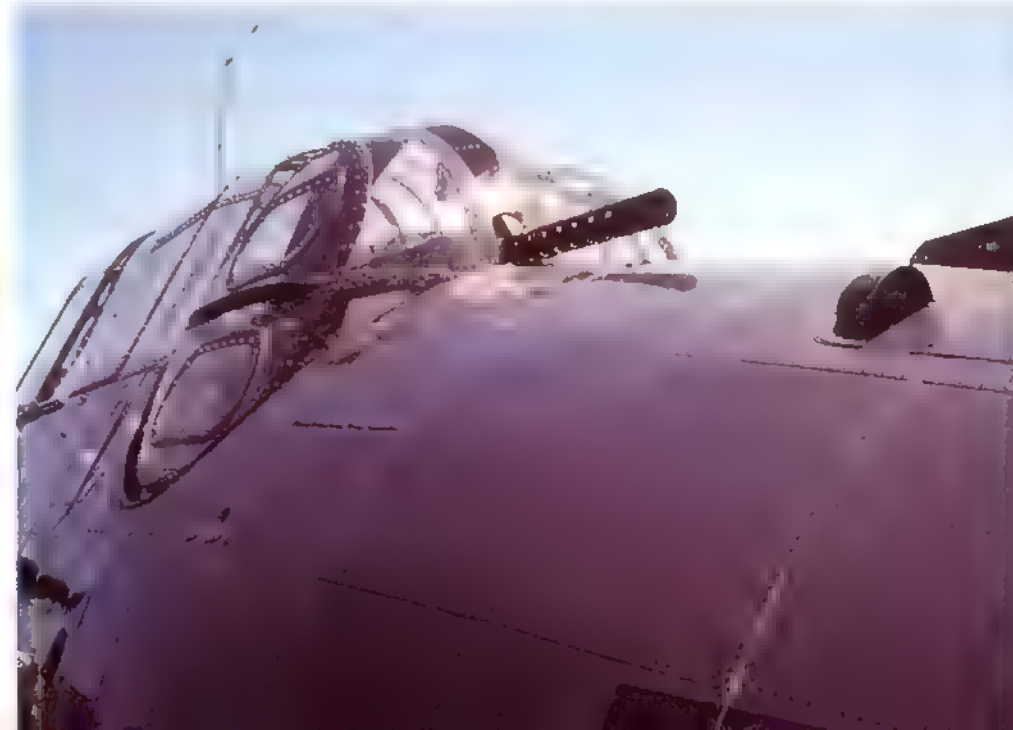
The vent aft of the turret allowed exhaust from the cabin heater to escape. This heater was installed in late production TBMs. The gunner operated the turret by holding down the gun handle's action switch. When this handle was released, the turret returned to the neutral position with the gun muzzle trailing aft. (Lou Drendel)

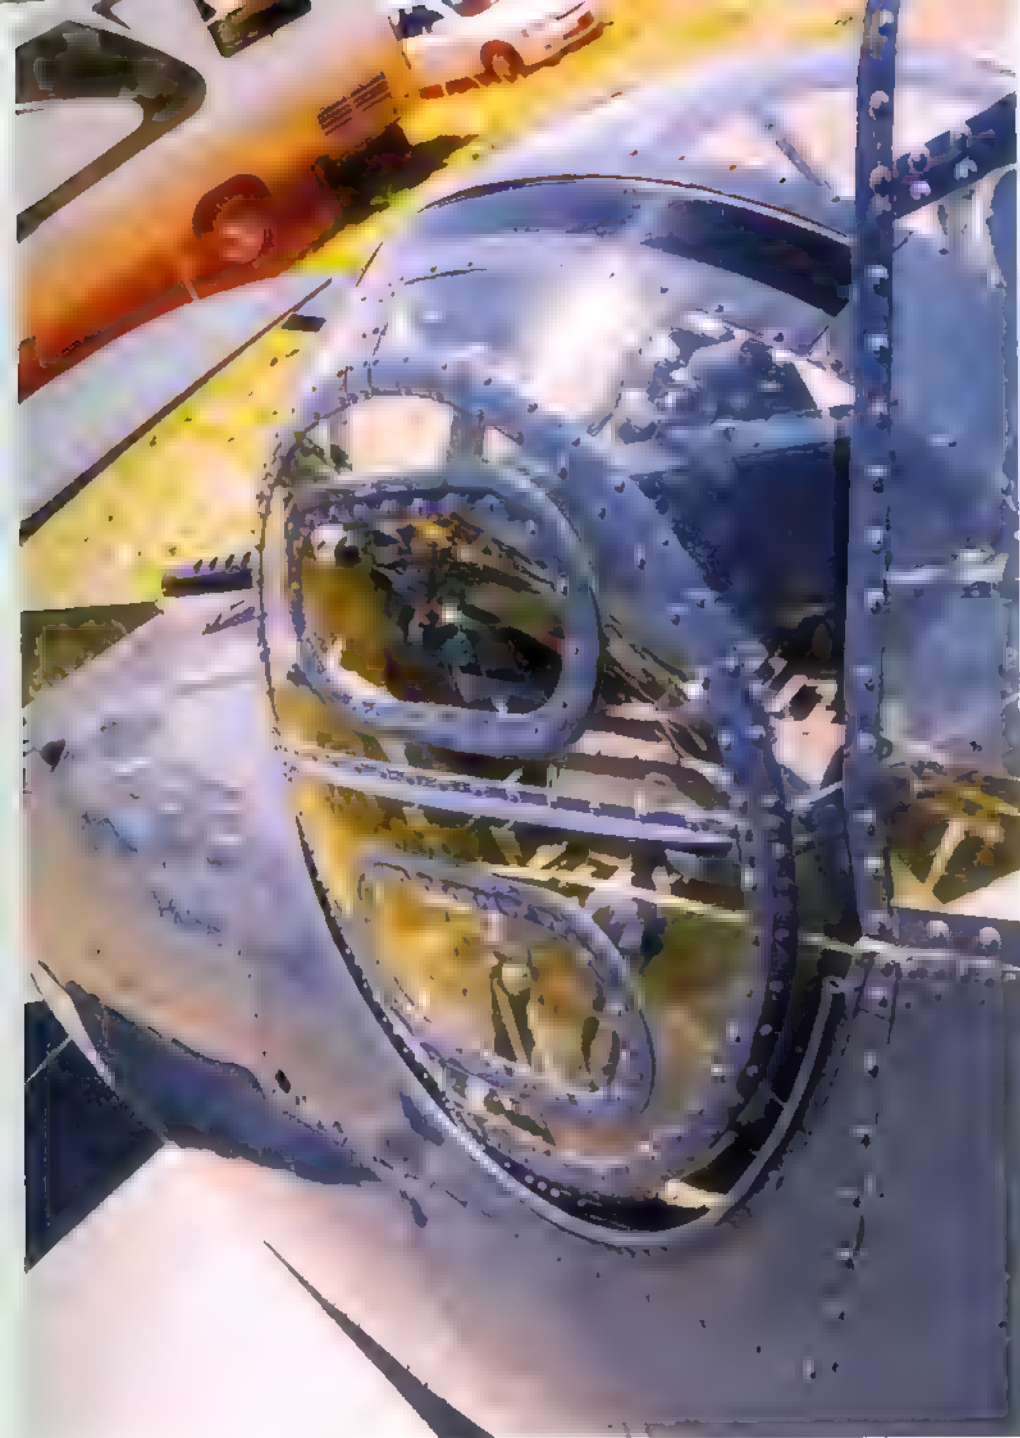
The turret operating mechanism contained interrupter cams, which activated a microswitch in the gun firing circuit. This microswitch prevented the gunner from accidentally shooting holes in the wing and/or tail surfaces in the heat of combat. The system only worked when the turret was electrically operated; any manual operation of the gun did not provide this safeguard. (Lou Drendel)

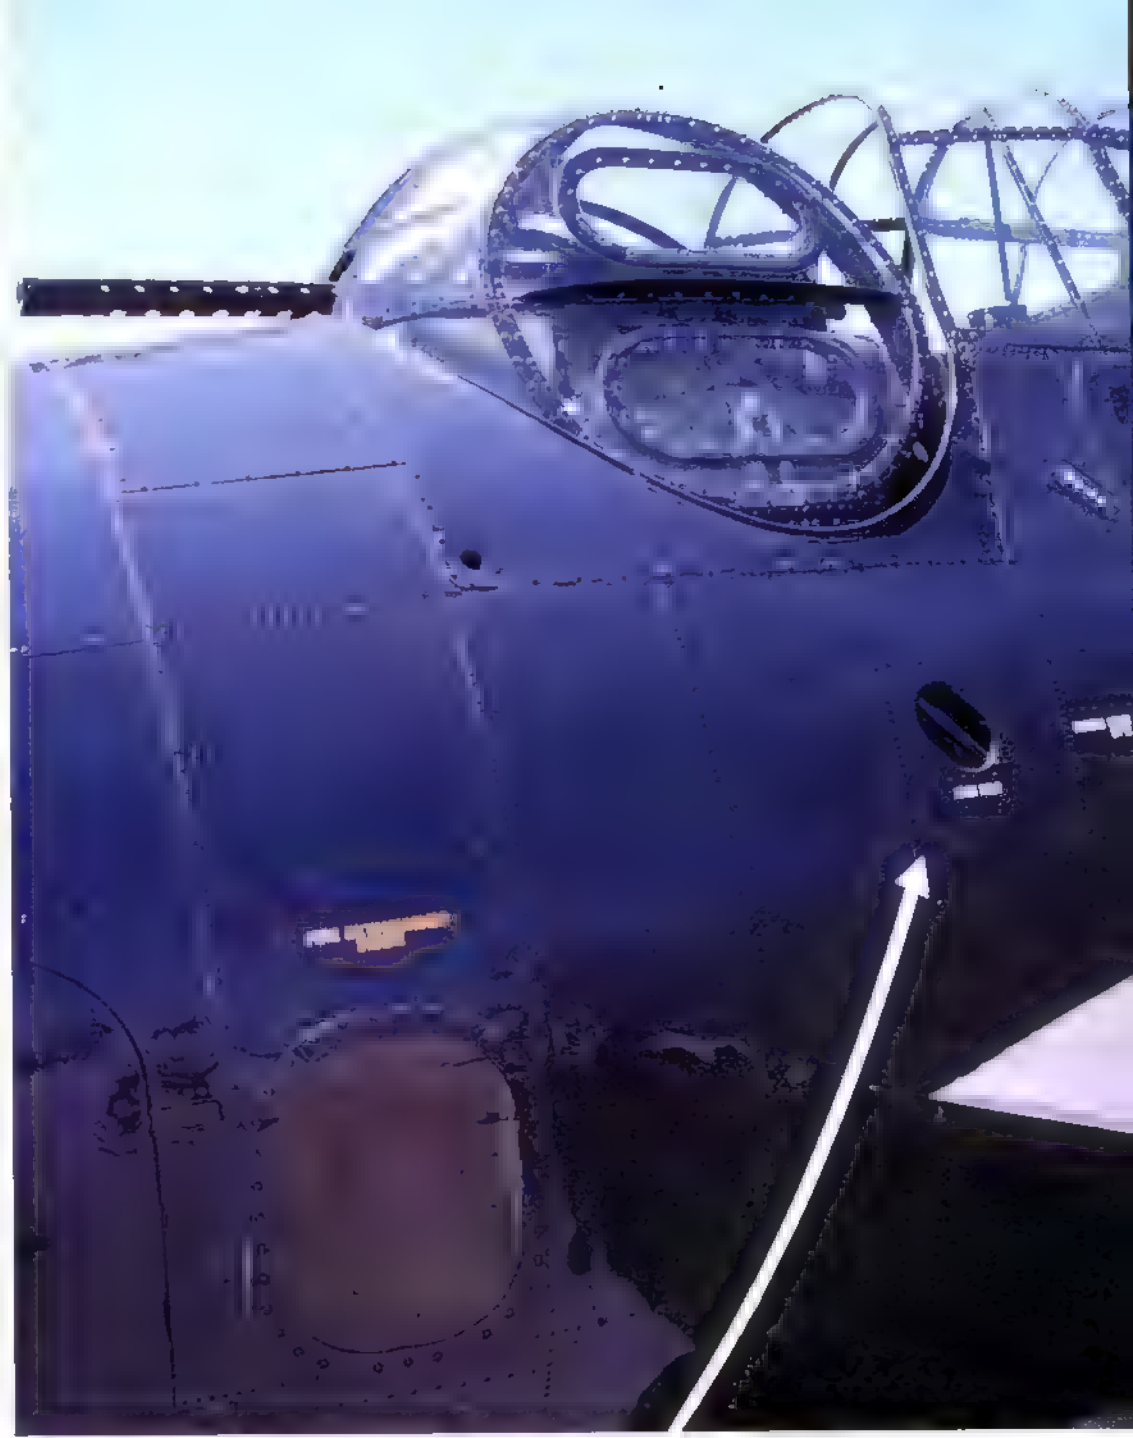
Crewmen used a hand hold below the turret and kick-in steps on the lower fuselage to climb aboard the aircraft's wing. A white diagonal line with an arrowhead at the top guided personnel in boarding the aircraft. The rear fuselage access door was placed aft of the window on the Avenger's starboard side. (Lou Drendel)

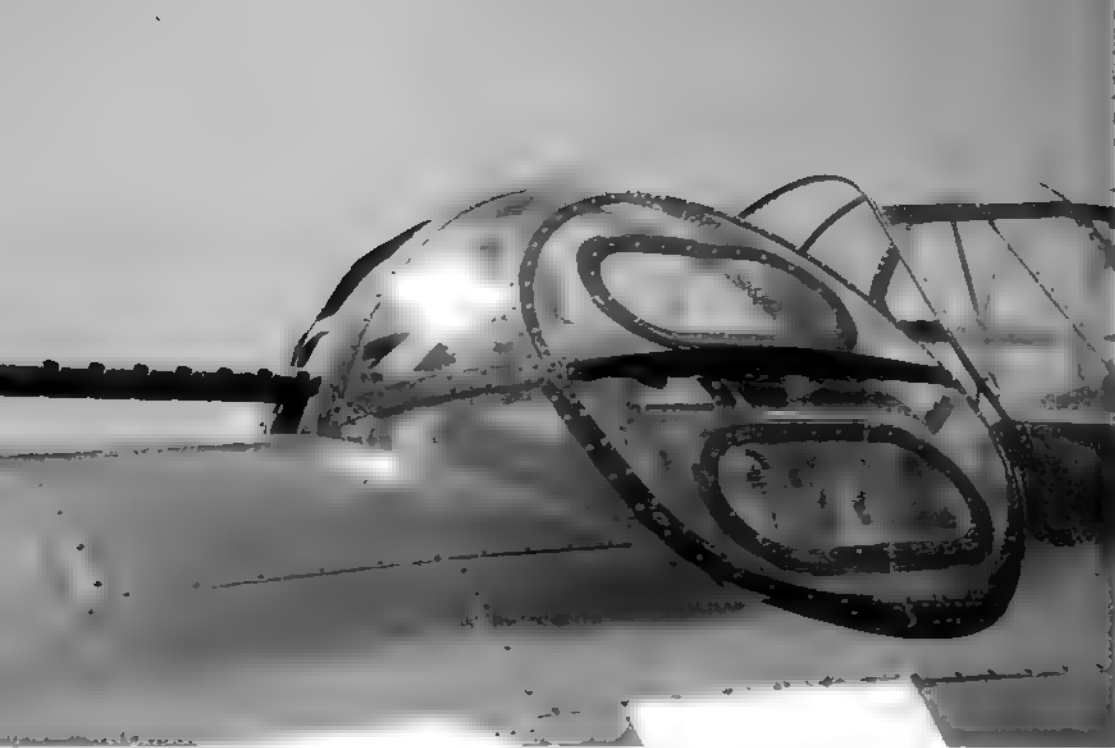
Ammunition for the .50 caliber (12.7mm) Colt-Browning M2 machine gun was stored in the turret's port side. Belted ammunition was fed through the port side of the weapon's breech and spent shell casings were ejected through a chute to a box mounted below the gun. The air-cooled M2 had a cyclic rate of 800 rounds per minute and a muzzle velocity of 2900 feet (883.9 m) per second. (Lou Drendel)

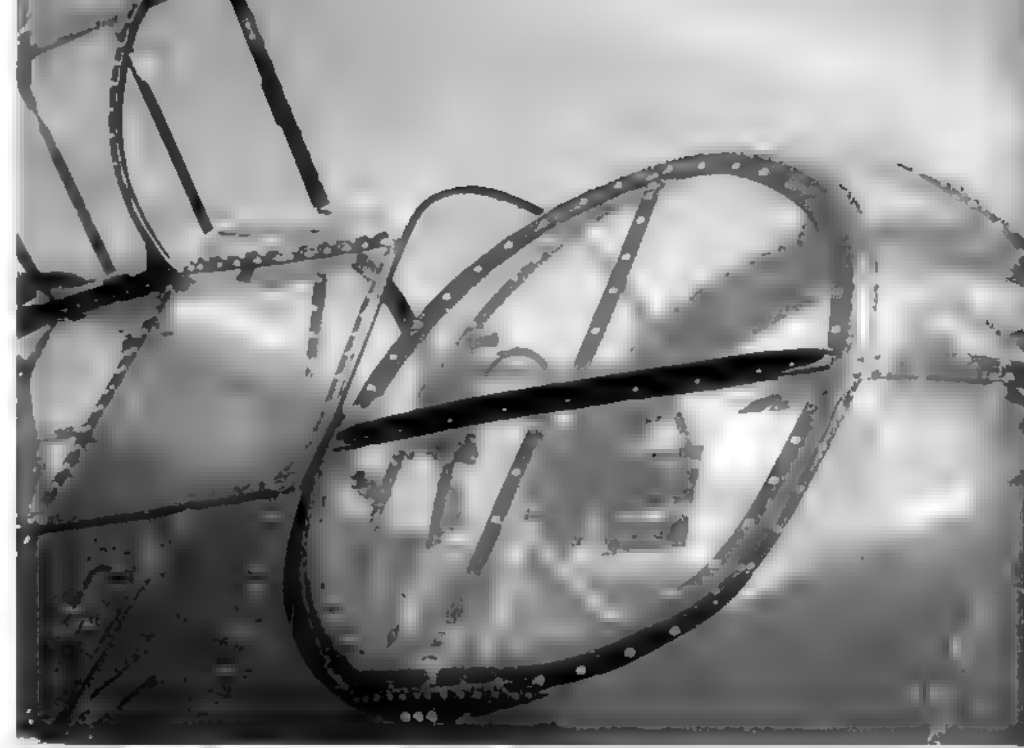
The electrically-powered Grumman 150SE turret could move at the rate of 30° per second in elevation and 45° per second in train (sideways). It was capable of training 360° and had vertical limits of -30° to +85°. The gunner was protected by armor plating, which was .5 inch (12.7mm) thick at his front, .375 inch (9.5mm) thick at the sides, and .75 inch (19.1mm) thick at the bottom. (Lou Drendel)

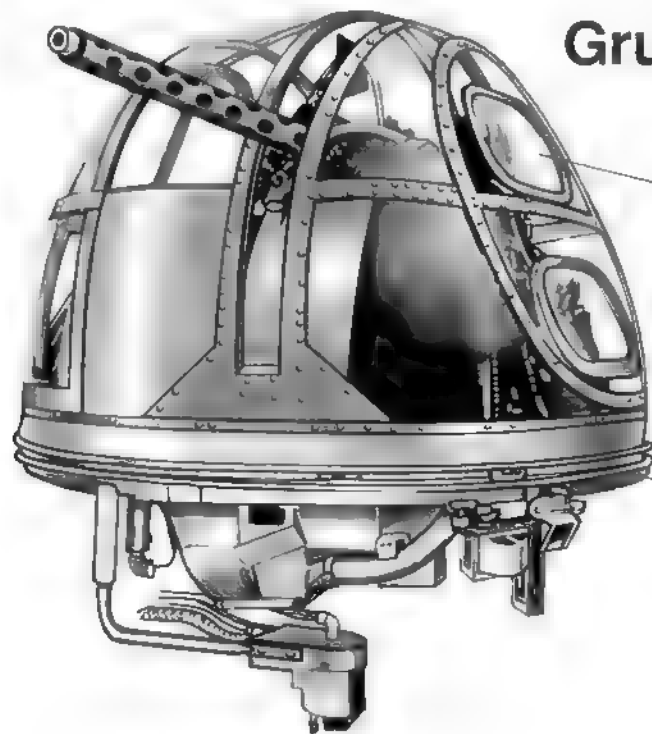
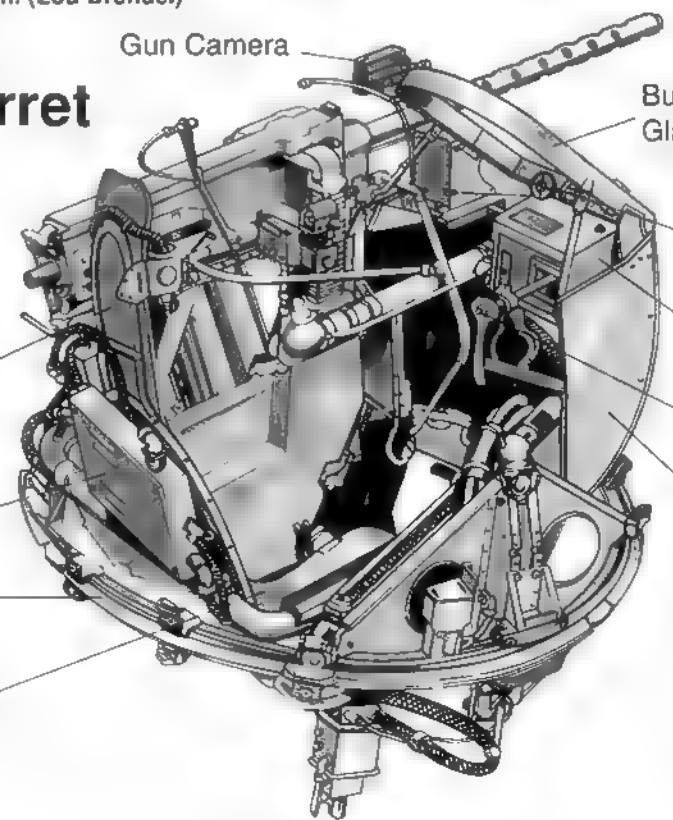
Grumman 150SE Turret

Front

Plexiglas Panels

Back

Control
Handle

Armor
Plate
